# Manhole Inspection Summary

Manhole # S17UU\_009MH

**Location** Address: **REAR OF 3120 REISTERSTOWN RD** Cross Street: **CHOWAN AVE**

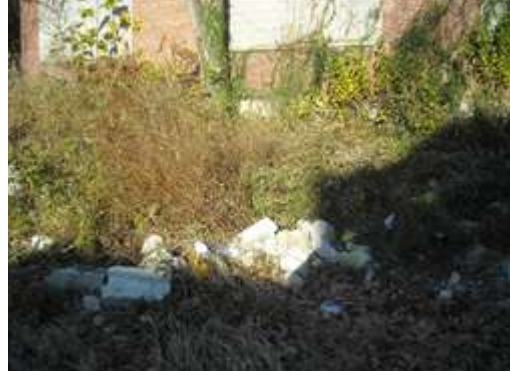
DEBRIS AROUND WHERE MH SHOULD BE

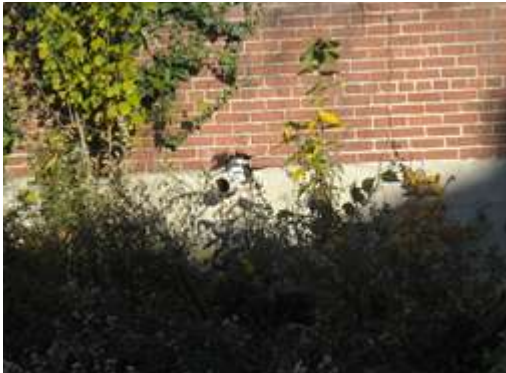
WATER BEING DUMPED INTO AREA WHERE MH SHOULD BE
